**BASELINE AQUATIC PLANT MONITORING: PRE-TREATMENT
FOR A SONAR[®] DEMONSTRATION PROJECT
AT EAGLE LAKE, NEW YORK**

December 1998

DFWI Technical Report 98-9

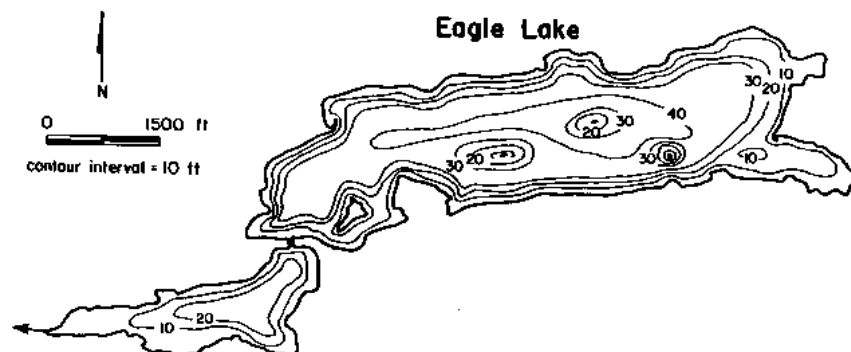
Figure 1. Depth (bathymetric) map of Eagle Lake

The lake has a surface area of 420 acres and a steeply sloping watershed of 3452 acres (Mikol and Polsinelli, 1985). Eagle Lake has a maximum depth of 12.8 meters (42 feet) and a mean depth of 5.8 meters (19 feet). Located on the western margin is the only outlet, which is dammed and used to maintain the level of the lake. The lake bottom slopes rapidly away from the shoreline in most places, with limited areas for the growth of aquatic plants.

The lake is separated into two distinct basins (East and West) by a shallow, narrow channel which is confined by a highway bridge for NYS Route 73. Eagle Lake is a soft water, low alkalinity water body typical of many lakes in the Adirondack region of New York. It is dimictic, exhibiting both summer and winter thermal stratification. The lake is best classified as oligotrophic; nutrients necessary for the growth of algae and, subsequently, the myriad of organisms that feed on these plants, are low.

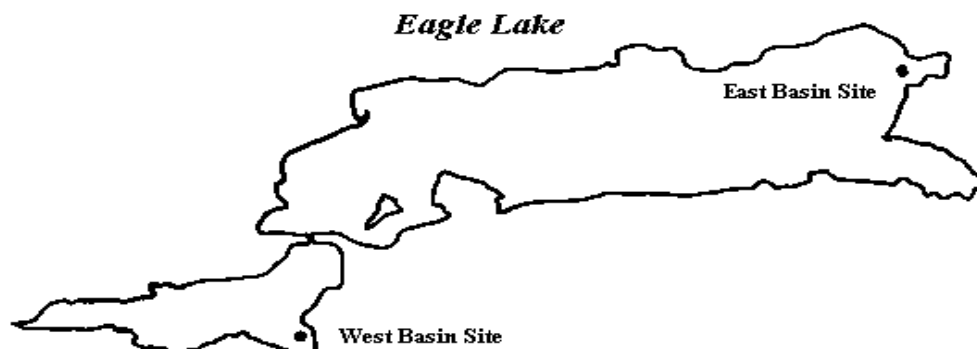
Figure 2. Map of sampling sites for Eagle Lake.

Two sites at Eagle Lake were selected for plant community composition analysis. One site was chosen for each sub-basin of Eagle Lake (Figure 2). Plant community composition was determined by relative percent cover of each species within a series of gridded plots installed at each location. Each grid consisted of 18 contiguous 1m² plots. Three grids were placed at each survey site for a total of 54 plots per survey site.
